CALAIS TOWN  
HALL REHABILITATION  
PLAN  
2.6.17

Town of Calais  
Calais, Vermont

**CALAIS TOWN HALL REHABILITATION PLAN**

February 6, 2017

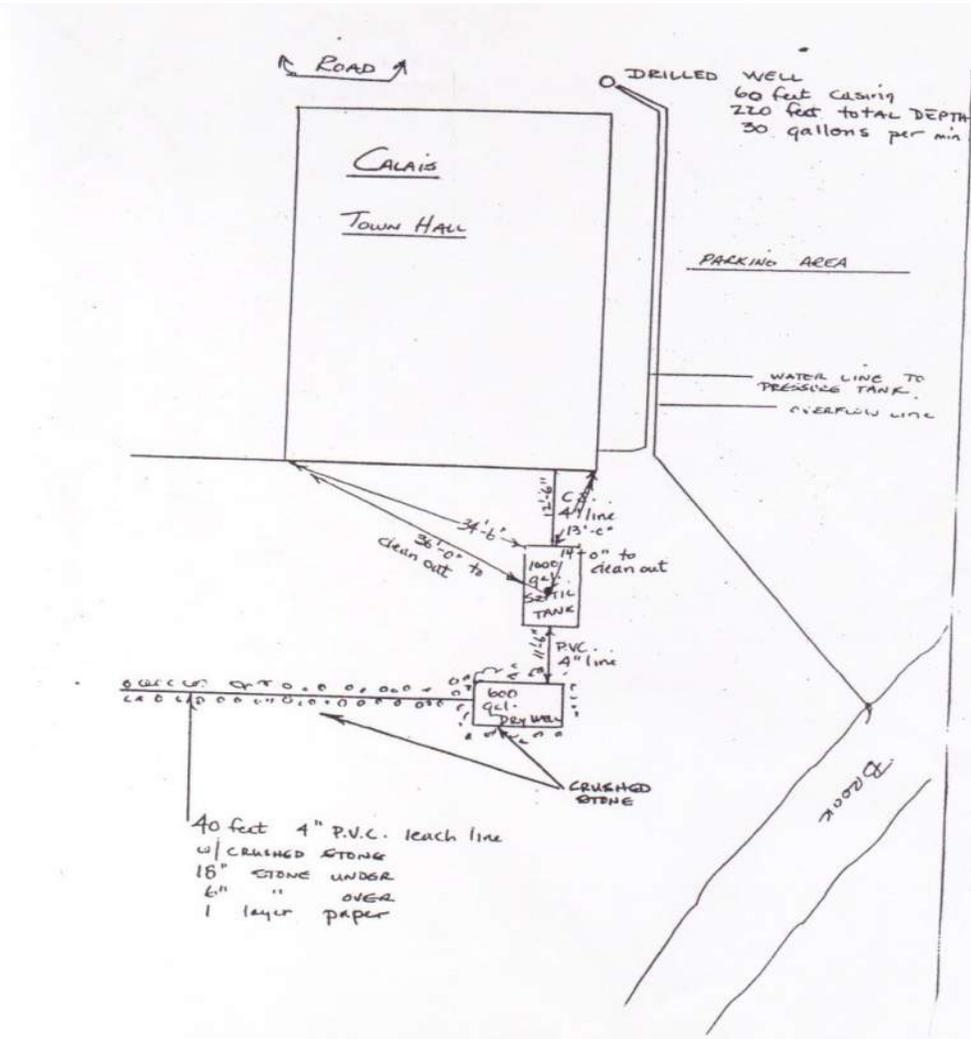
**SCHEMATIC SKETCH OF EXISTING SEPTIC DISPOSAL SYSTEM**

A schematic drawing of the existing septic disposal system was provided by the Calais Historic Preservation Commission (see below). The system consists of a septic tank and a dry well. This system is allowed as an existing system with intermittent use. If the building is to be considered for full time use or for events, improvements may be required.

- Provide periodic maintenance and inspection of the system including pumping out the septic tank.
- Monitor periodically and review for potential failure.
- Protect the system from damage during construction activities.
- Plan for further evaluation, replacement or use of portable toilets if more sustained use or a change of use is anticipated.

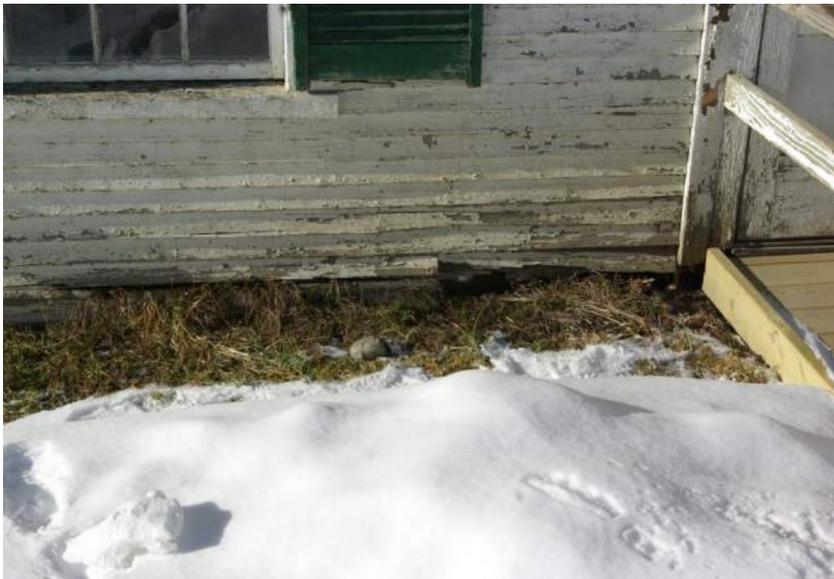
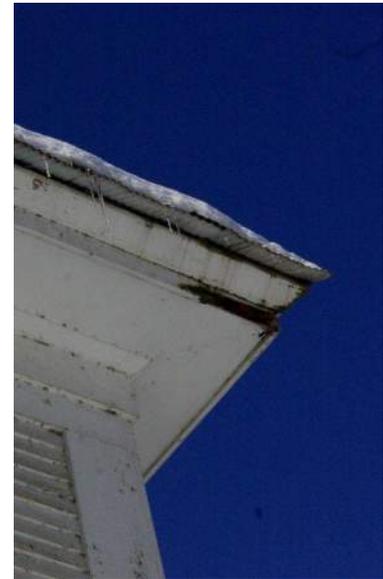
The clapboard siding and trim on the Town Hall is generally in good condition for a building of this age. The clapboard siding and trim on the stair addition is in fair condition.

At the northeast corner of the roof eave, the vertical trim board is water damaged.

At the lower entrance (northeast corner of the building), water run-off from the main roof is causing damage to the wood clapboards above entrance roof below and to the sides of the entrance.

- At the northeast corner of the roof eave, the vertical trim board that is water damaged needs to be replaced
- The existing skirtboards and approximately three to four courses of clapboard siding above the skirtboard on all sides of the Town Hall and stair addition need to be replaced.
- There are a number of rotted and damaged clapboards and trim at the stair addition that need to be replaced.
- Water damaged clapboards above and to the sides of the lower floor entrance roof need to be replaced. A roof gutter or rain diverter should be installed at the main roof to divert water from falling onto the lower floor entrance roof.

- All damaged/rotted clapboards and trim that are replaced, should be replaced in kind, matching material, the dimensions and profiles of the existing clapboards and trim pieces.
- Clapboards and trim are to be scraped of all loose paint, sanded, prepped for painting, primed, painted (one coat of primer and two coats of finish paint) and joints caulked and sealed.

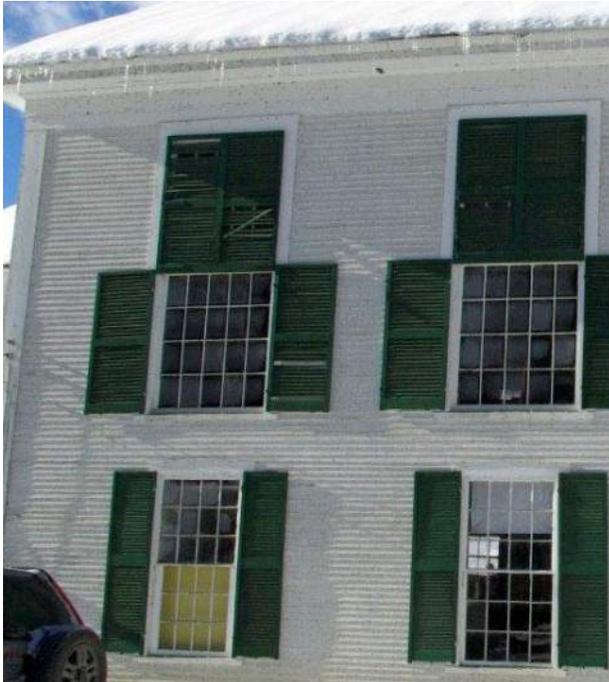
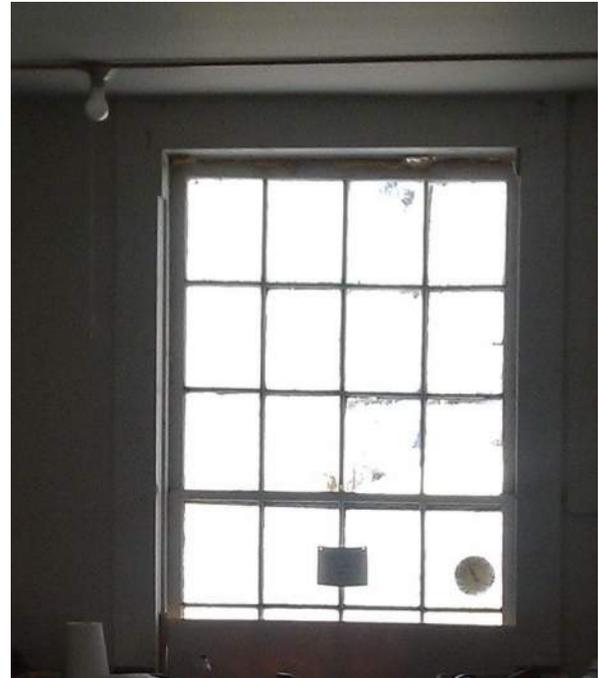
The existing upper windows have been recently restored and no future work is anticipated. The existing lower windows are not restored and are in fair condition. A majority of the lower window glass is original. There are window sash parts that need to be replaced. Quite a few of the existing windows are currently not properly closed. There are gaps where the heads of the upper sash meet the head of the window frame; in some cases insulation has been placed to fill the gaps. There are no mechanisms in place for operating the windows.

At the lower floor existing windows, there are a number of broken and missing window panes that need to be replaced.

The upper window shutters were recently restored. A number of the existing lower window shutters have broken and missing louver blades. The existing lower window shutters will be removed and restored. The restored lower window shutters and the restored upper window shutters will be reinstalled.

- The existing historic windows at the lower floor are to be retained, removed from the building and repaired in-kind, matching the dimensions and profile of the historic material. Windows are to be re-installed so that they can be closed properly.

- Windows are to be scraped of all loose paint, sanded, prepped for painting, primed and painted (one coat of primer and two coats of finish paint).
- Replace missing or broken glass panes

- Replace deteriorated and/or missing glazing bead.
- New triple track metal storm window systems
- At the jambs and meeting rails, saw kerfs will be cut into the existing windows sashes and pre-bent metal weather stripping will be installed. At the top of the upper sash and the bottom of the lower sash provide and install blub type weather stripping.

- Replace missing and damaged louver blades on window shutters, which are to be replaced in-kind, matching the dimensions and profile of the historic material. Shutters are to be scraped of all loose paint, sanded, prepped for painting, primed and painted (one coat of primer and two coats of finish paint).

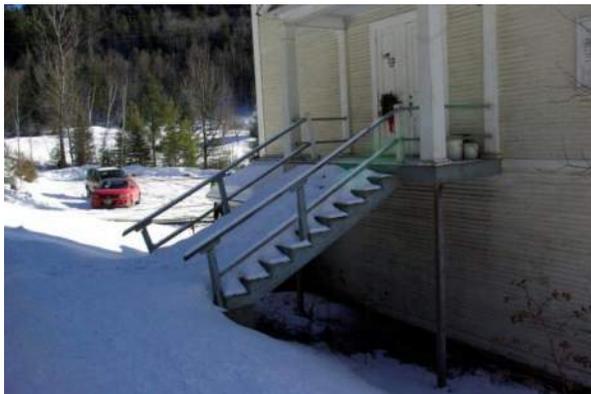
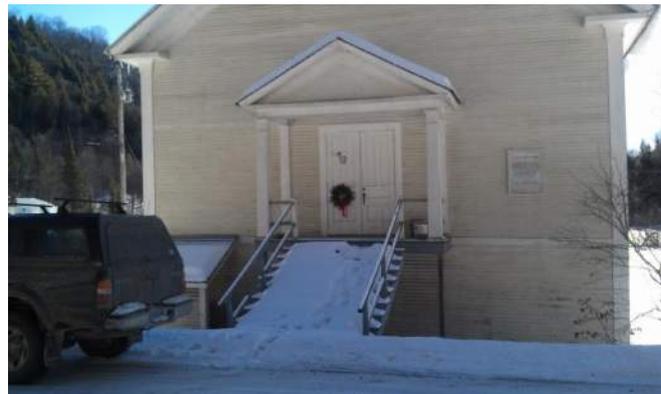
The current front porch and stairs do not meet code for fall protection. Due to the front porch and stair height above grade, a guard rail is required at a height of 42 inches above the floor of the porch. Guards are required to have intermediate rails or ornamental pattern such that a sphere 4 inches in diameter is not able to pass through any opening. A handrail is required at the stairs and needs to be located at a height of not less than 34 inches and no more than 38 inches above the surface of the tread. Due to the width of the existing stairs, an intermediate handrail is required at the center of the stair for the entire run of the stair.

- At the existing Front Porch, remove the existing wood railings and provide and install a new wood guard rail at a height of 42 inches above the porch deck and intermediate rails or ornamental pattern such that a sphere 4 inches in diameter is not able to pass through any opening.

- At the existing stair, remove the existing wood railings and provide and install a new wood guard rail at a height of 42 inches above the stair tread and intermediate rails or ornamental pattern such that a sphere 4 inches in diameter is not able to pass through any opening. Provide and install a new wood handrail at the stairs, located at a height of not less than 34 inches and no more than 38 inches above the surface of the tread. Provide and install a new intermediate railing at the center of the stair.

- Since the recommendation is to raise the building 12 inches, then the existing stair will need to be removed and replaced. A new wood stair framing system will be installed with three concrete sono tubes for the end of the stairs to sit on. New treads to be a minimum of 11 inches deep and risers to be a maximum of 7 inches high. New railings and guards will need to be installed at the same dimensional requirements as required for the exiting stair.

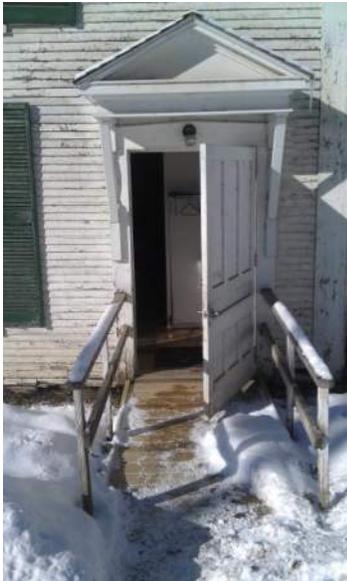
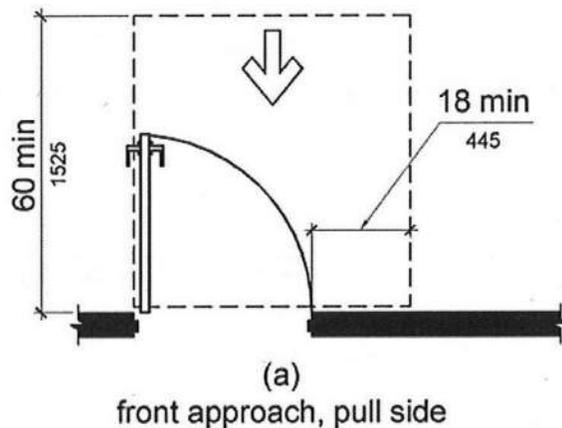
The lower floor accessible entrance does not meet accessibility requirements. On a front approach to a door, 18 inches clear is required parallel to the door, beyond the latch side, There currently is approximately 4 inches. The door swing cannot be changed to swing into the building, since the lower floor has a capacity of more than 50 occupants. When there are more than 50 occupants in a space, all doors are required to swing in the direction of egress.

- The existing “bridge” needs to be made wider to accommodate the additional 18 inches clearance for a requirement for a depth of 60 inches and this area of the parking lot would be re-graded so that this entrance is accessible without a “ramp.”

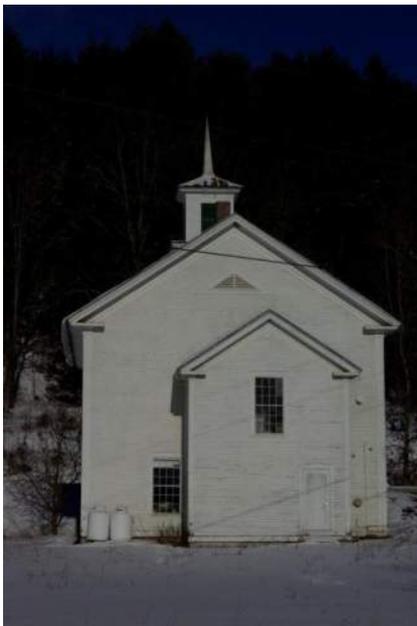
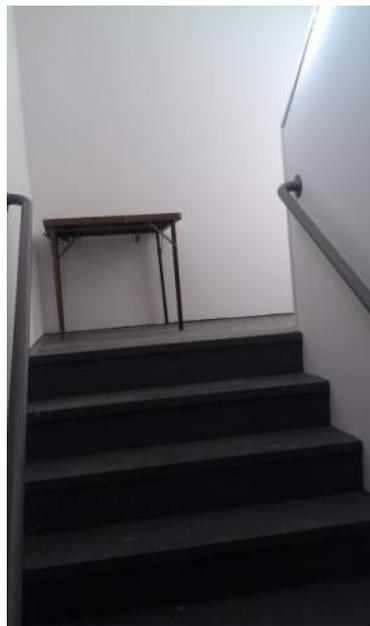
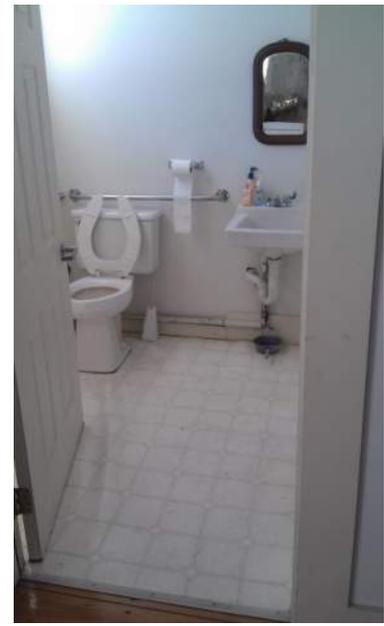
The lower and upper floor plans are original except for a rear stair addition and an interior chair lift and enclosure that have been added at the front of the building. The existing chair lift does not meet current accessibility codes.

At the lower floor, the existing bathroom at the lower floor plan does not meet accessibility requirements. The existing door swings into the space and into the clear floor space of the toilet and sink which is not allowed.

- A new addition off the existing stair addition could be constructed to accommodate a new code complaint chair lift. The existing salvaged doors will be reinstalled. This would allow for the lower and upper floors to be returned to their original historic appearance.
- At the existing lower floor bathroom, change the swing of the existing door swing so that the door swings out instead of in.

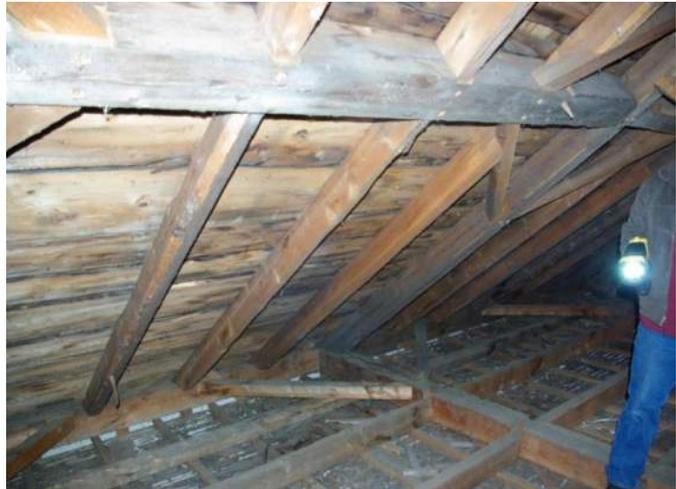
**TYPICAL ROOF FRAMING- RAFTERS AND PURLINS**

The 3 x 6 rafters are supported at intermediate 7 x 7 purlins running between the trusses. The rafters and purlins appear straight and in good condition. The rafters appear to meet current code requirements while the purlins appear to be below code requirements.

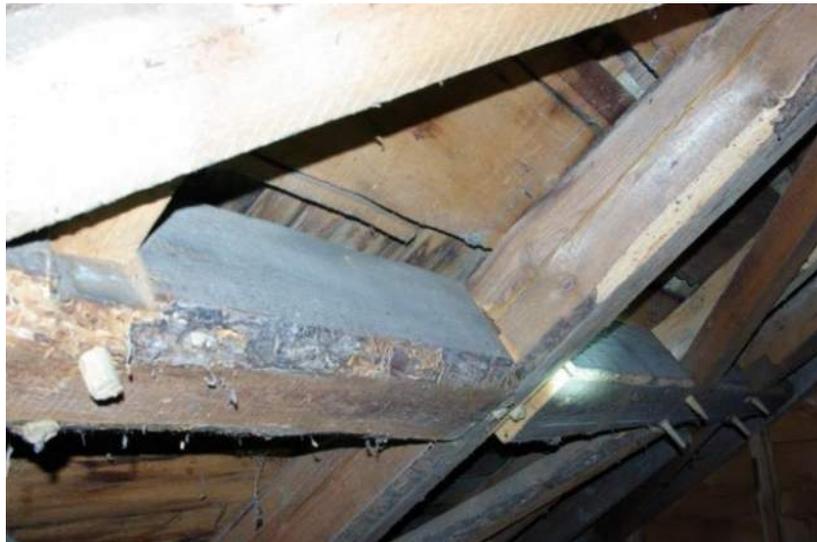
**PURLIN TO QUEEN POST TRUSS CONNECTION- SPLIT IN TOP CHORD**

The Queen Post truss at the steeple shows signs of deflection with some splitting of the top chord at the purlin connection. (see photo at right). The leaning of the steeple observable from the outside is an indicator that there has been deflection of this truss. The configuration of a Queen Post truss (without a diagonal member at the center portion) is not as stiff as the King Post trusses and allows the bottom chord to develop very high stresses.

- The Queen Post roof truss should be evaluated in further detail and improvements made to repair damaged members and stiffen the truss.
- The rotted section of framing at the south near the chimney should be replaced or repaired.

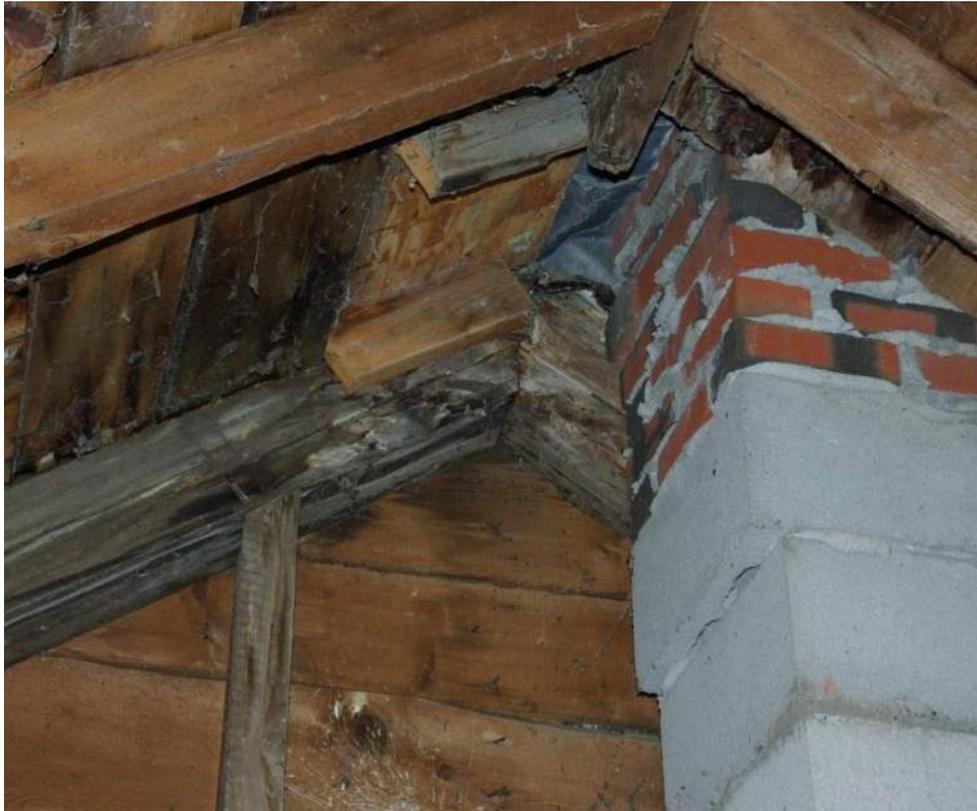
A small section of rotted framing was noted at the south side near the chimney.

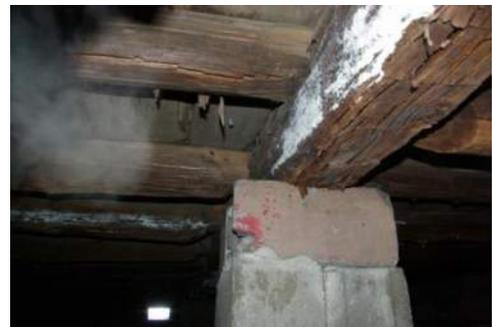
**Rotted and Moldy Beams**

The proximity of the very damp soil conditions in the crawl space to the framing has allowed the timbers to have very high moisture content. Framing for the north two bays has rotted substantially to the point that its load carrying capacity is limited and mold is present.

- The rotted portion of the first-floor framing is currently a safety concern and the northern portion of the lower floor should not be occupied by more than two or three people at a time and with caution.
- Exterior sills should be evaluated in detail and replaced where rotted.

- In lieu of repairing the first-floor framing and wet flood proofing (allowing water into the crawl space), remove the existing wood floor and salvage for reuse. Remove and dispose of the existing wood floor framing system including mid-span beams and pier supports for beams and cmu grade wall. Excavate as required for new reinforced concrete footings and foundation walls. The top of footings are to be located 5 feet 6 inches below top of concrete slab. Provide and install 2 layers of 1 inch R5 rigid insulation at the inside face of the foundation wall from underside of new concrete slab to 4 feet below grade. Provide and install 6 inches compacted gravel, 30 inches of structural fill, vapor barrier and 4 inches thick concrete reinforced slab (dry flood proofing). Provide and install 2 layers of 1 inch R5 rigid insulation under the entire concrete slab. Joints taped and sealed. Provide and install double pressure treated 2 x 8 sill plates with 5/8 inch anchor bolts at 36 inches on center at the underside of the existing exterior walls. Provide and install sill sealer between the sill plates and concrete slab. On top of the new concrete slab, attach new 1 x 4 pressure treated sleepers and reinstall salvaged wood floor. This greatly simplifies the issues of moisture control.

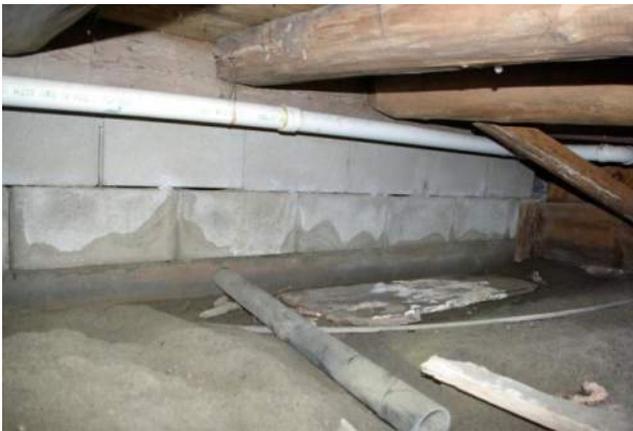
**Existing CMU Masonry Grade Wall**

The existing exterior grade wall is in fair condition. There are areas where there is noticeable shifting and deterioration of the wall. The interior CMU masonry piers appear to be dry laid (no mortar in the joints) and are in fair condition.

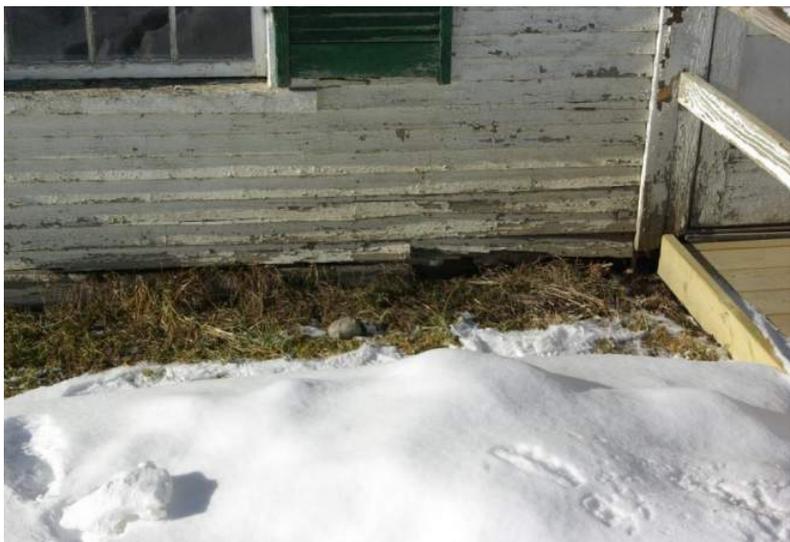
**Buried Sills at Parking Lot Side of Building**

Timber sills were noted to have rotted especially at the north and east sides of the building where they are in contact with the ground.
