CALAIS TOWN HALL REPORT

February 25, 2013

Site and Building Assessment and Findings

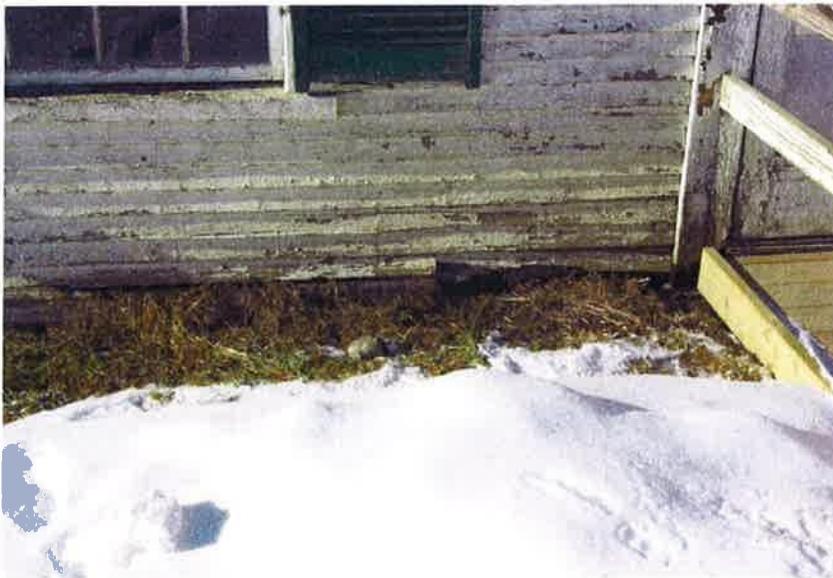
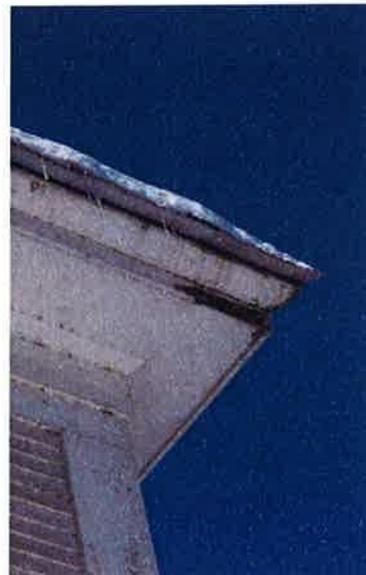
The clapboard siding and trim on the Town Hall is generally in good condition for a building of this age. The clapboard siding and trim on the stair addition is in fair condition.

At the northeast corner of the roof eave, the vertical trim board is water damaged.

At the lower entrance (northeast corner of the building), water run-off from the main roof is causing damage to the wood clapboards above entrance roof below and to the sides of the entrance.

- At the northeast corner of the roof eave, the vertical trim board that is water damaged needs to be replaced
- The existing skirtboards and approximately three-four courses of clapboard siding above the skirtboard on all sides of the Town Hall and stair addition need to be replaced.

- There are a number of rotted and damaged clapboards and trim at the stair addition that need to be replaced.
- Water damaged clapboards above and to the sides of the lower floor entrance roof need to be replaced. A roof gutter or rain diverted should be installed at the main roof to divert water from falling onto the lower floor entrance roof.

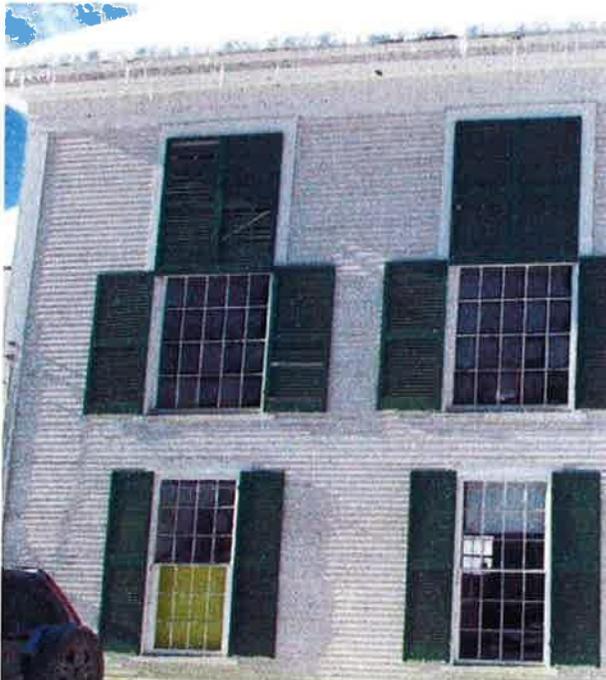
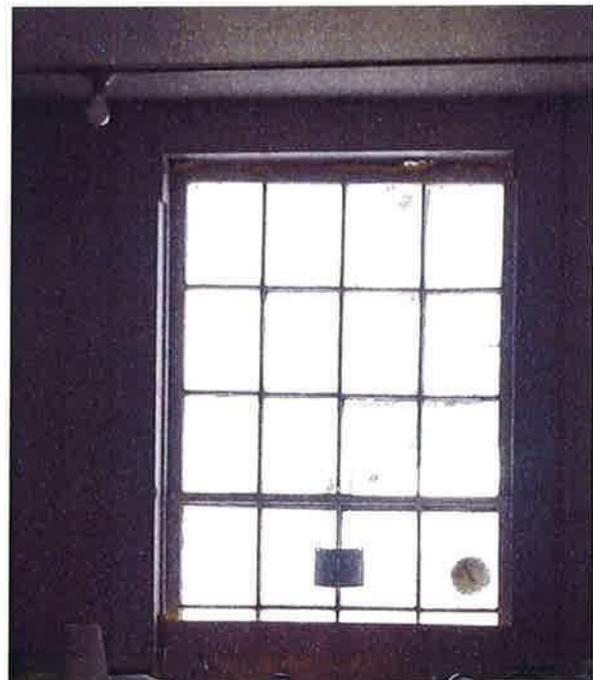
The windows are in fair condition and a majority of the window glass is original. There are window sash parts that need to be replaced. Quite a few of the existing windows are currently not properly closed. There are gaps where the heads of the upper sash meet the head of the window frame; in some cases insulation has been placed to fill the gaps. There are no mechanisms in place for operating the windows.

There are a number of broken and missing window panes.

A number of existing shutters have broken and missing louver blades.

- The historic windows are to be retained, removed from the building and repaired in-kind, matching the dimensions and profile of the historic material. Windows are to be re-installed so that they can be closed properly.
- Windows are to be scraped of all loose paint, sanded, prepped for painting, primed and painted (one coat of primer and two coats of finish paint).
- Replace missing or broken glass panes
- Replace deteriorated and/or missing glazing bead.
- Replace missing and damaged louver blades on window shutters, which are to be replaced in-kind, matching the dimensions and profile of the historic material. Shutters are to be scraped of all loose paint, sanded, prepped for painting, primed and painted (one coat of primer and two coats of finish paint).

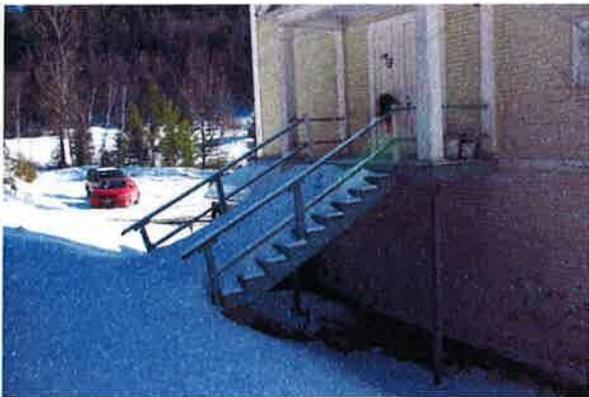
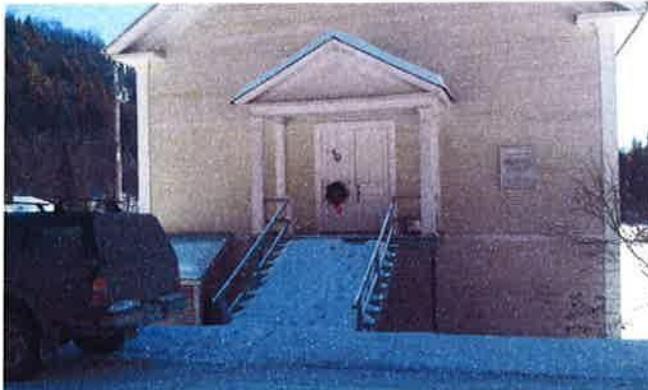
The current front porch and stairs do not meet code for fall protection. Due to the front porch and stair height above grade, a guard rail is required at a height of 42” above the floor of the porch. Guards are required to have intermediate rails or ornamental pattern such that a sphere 4 inches in diameter is not able to pass through any opening. A handrail is required at the stairs and needs to be located at a height of not less than 34 inches and no more than 38” above the surface of the tread. Due to the width of the existing stairs, an intermediate handrail is required at the center of the stair for the entire run of the stair.

- At the existing Front Porch, remove the existing wood railings and provide and install a new wood guard rail at a height of 42” above the porch deck and intermediate rails or ornamental pattern such that a sphere 4 inches in diameter is not able to pass through any opening.

- At the existing stair, remove the existing wood railings and provide and install a new wood guard rail at a height of 42” above the stair tread and intermediate rails or ornamental pattern such that a sphere 4 inches in diameter is not able to pass through any opening. Provide and install a new wood handrail at the stairs, located at a height of not less than 34 inches and no more than 38” above the surface of the tread. Provide and install a new intermediate railing at the center of the stair.

- If the recommendation to raise the building 2’-3’ is accepted, then the existing stair will need to be removed and replaced. A new wood stair framing system will be installed with three concrete sono tubes for the end of the stairs to sit on. New treads to be a minimum of 11” deep and risers to be a maximum of 7” high. New railings and guards will need to be installed at the same dimensional requirements as required for the exiting stair.

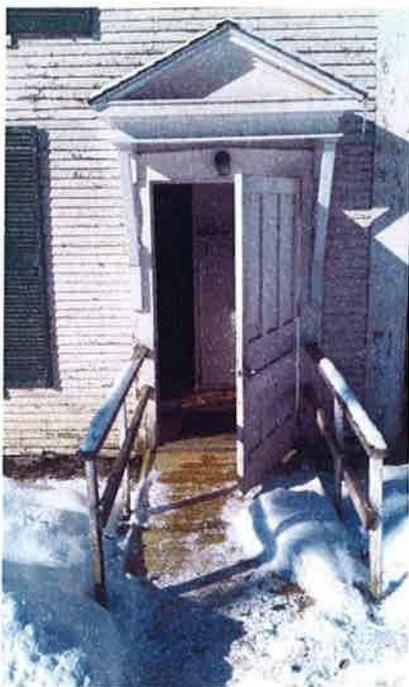
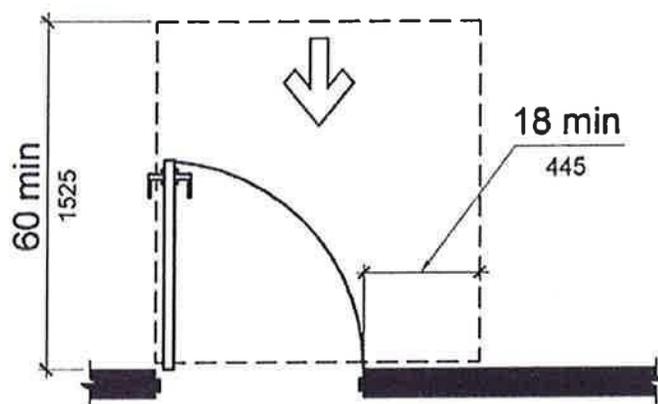
The lower floor accessible entrance does not meet accessibility requirements. On a front approach to a door, 18” clear is required parallel to the door, beyond the latch side, There currently is approximately 4”. The door swing cannot be changed to swing into the building, since the lower floor has a capacity of more than 50 occupants. When there are more than 50 occupants in a space, all doors are required to swing in the direction of egress.

- The existing “bridge” needs to be made wider to accommodate the additional 18” clearance for a requirement for a depth of 60”
- If the recommendation to raise the building 2’-3’ is accepted and the lift is relocated then stairs and railings would be installed at this location. If the recommendation to raise the building 2’-3’ is accepted and the lift is not relocated, then this area of the parking lot would be re-graded so that this entrance is accessible without a “bridge.”

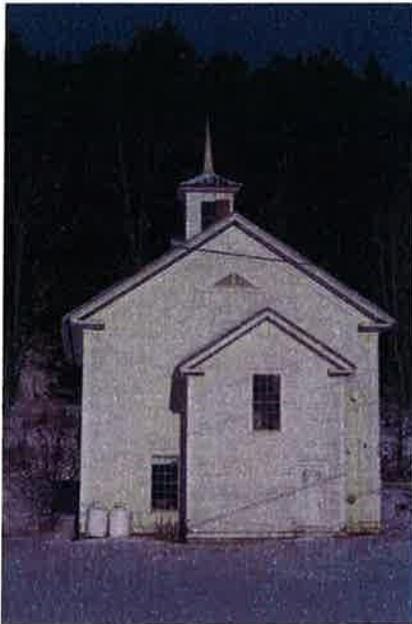
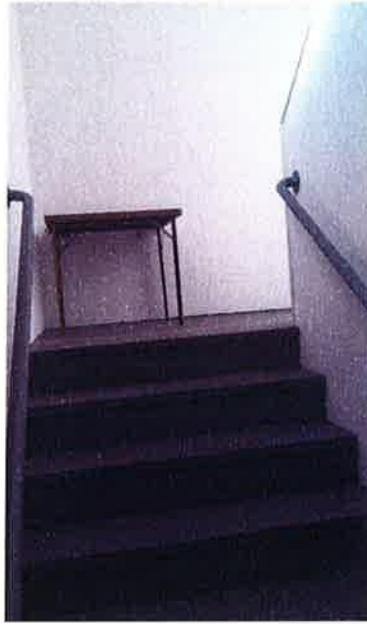
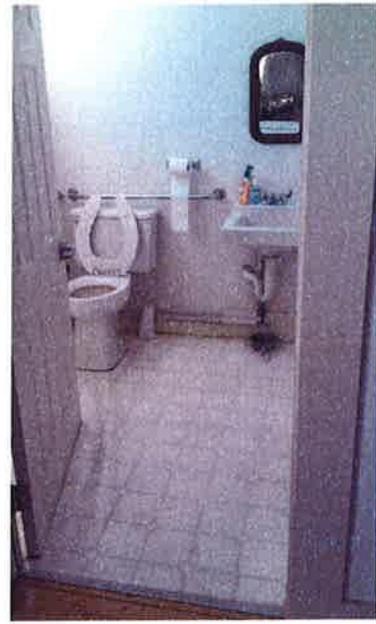
At the lower and upper floors there are existing exit lights and emergency egress lights. The existing exit lights were not illuminated. The existing emergency egress lights were not operating and their batteries may have to be replaced.

At the lower floor, the existing exterior door of the rear stair addition has a step down to grade of approximately 19.”

At the existing stair at the rear addition, the existing railing that is located on the center wall of the existing stair is required to be continuous.

- Confirm that the illuminated exit lights are still operable, if not, they will need to be replaced. Confirm that the batteries for the emergency egress lights will maintain a charge when power is turned on, if not then the existing batteries will need to be replaced.

- At the existing rear stair, remove the existing handrail at the center wall and install a new 1 1/2” diameter hardwood handrail that is continuous from the upper floor landing to the lower landing.

- At the existing exterior door at the rear stair addition. The height of the step cannot be greater than 7.” In order for the addition to be a means of egress, three steps need to be installed including a railing on both sides.

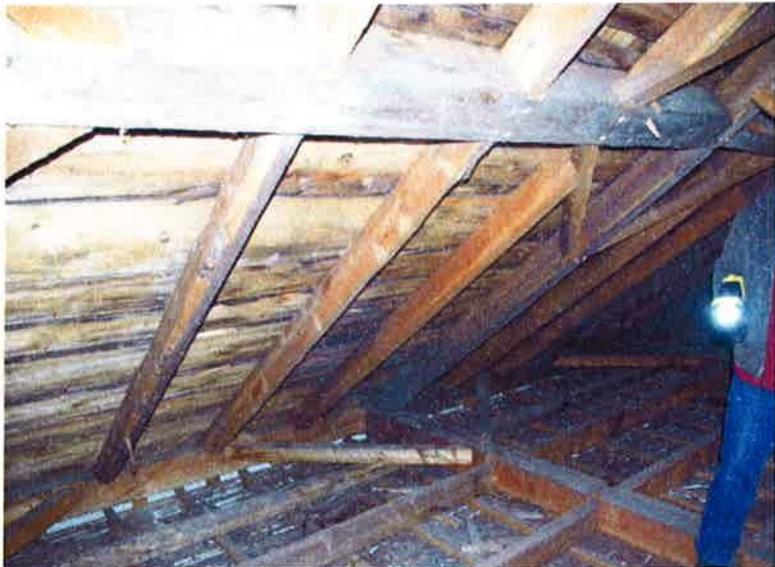
TYPICAL ROOF FRAMING- RAFTERS AND PURLINS

The roof framing was observed to be generally in good condition with a few notable exceptions. The roof is supported on two King Post trusses and a Queen Post truss at the steeple. Rafters are supported at intermediate 7" x 7" purlins running between the trusses.

The rafters and purlins appear straight and in good condition. The rafters appear to meet current code requirements while the purlins appear to be below code requirements.

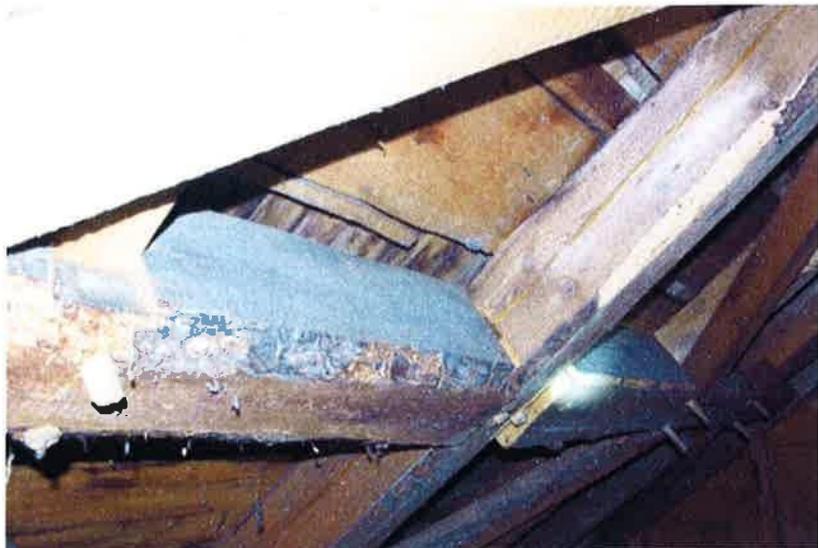
The Queen Post truss at the steeple shows signs of deflection with some splitting of the top chord at the purlin connection. (see photo at right). The leaning of the steeple observable from the outside is an indicator that there has been deflection of this truss. The configuration of a Queen Post truss (without a diagonal member at the center portion) is not as stiff as the King Post trusses and allows the bottom chord to develop very high stresses.

PURLIN TO QUEEN POST TRUSS CONNECTION- SPLIT IN TOP CHORD

- The Queen Post roof truss should be evaluated in further detail and improvements made to repair damaged members and stiffen the truss.
- The rotted section of framing at the south near the chimney should be replaced or repaired.

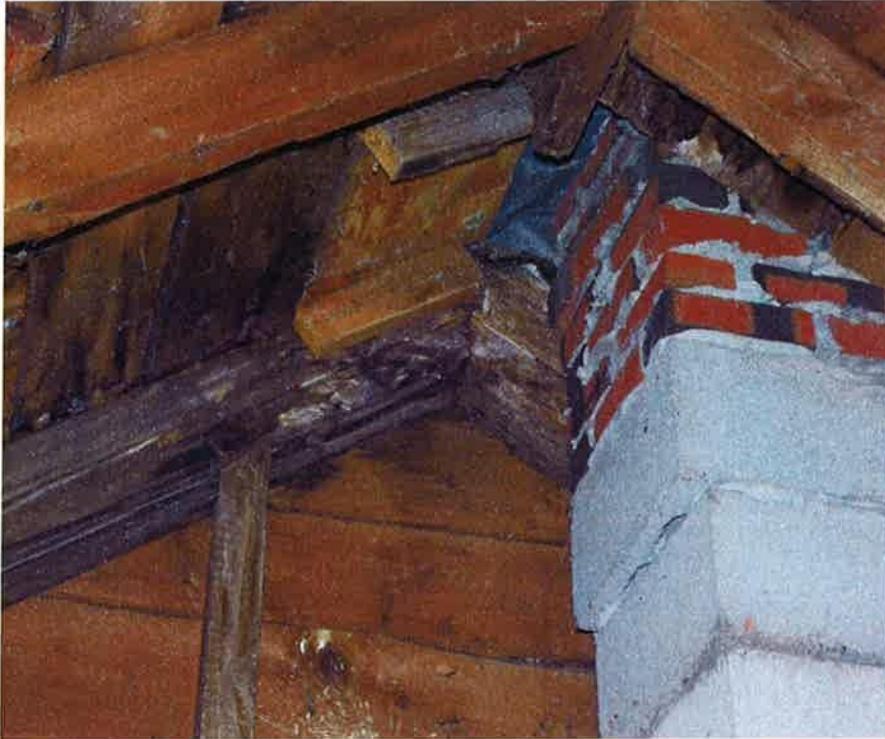
A small section of rotted framing was noted at the south side near the chimney.

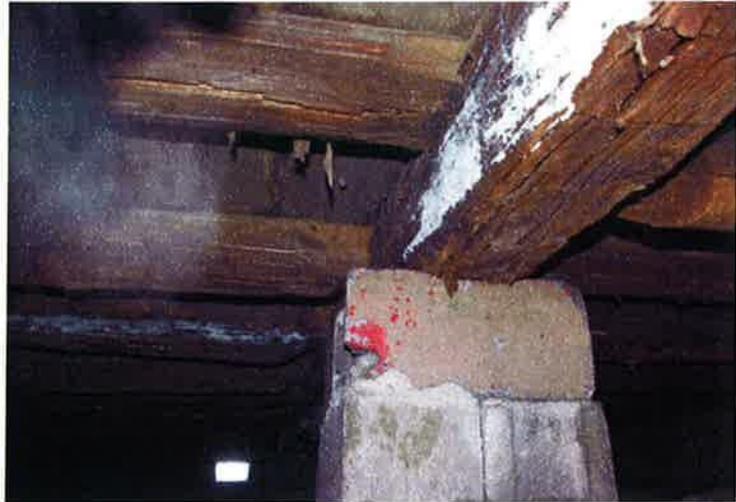
Rotted and Moldy Beams

The proximity of the very damp soil conditions in the crawl space to the framing has allowed the timbers to have very high moisture content. Framing for the north two bays has rotted substantially to the point that its load carrying capacity is limited and mold is present.

- The rotted portion of the first floor framing must be replaced or repaired. This is currently a safety concern and the northern portion of the first floor should not be occupied by more than two or three people at a time. Temporary shoring of the rotted beams and joists should be considered.
- Exterior sills should be evaluated in detail and replaced where rotted.
- Interior piers should be reconstructed with suitable cast-in-place concrete piers or fully mortared and reinforced masonry piers with footings placed at frost depth.
- The exterior foundation wall should be further investigated by excavating along the perimeter of the building and replaced or repaired.
- A new vapor barrier and mud slab should be installed in the crawl space to minimize future moisture damage.
- All work related to first floor framing and foundation should be coordinated with flood mitigation efforts.

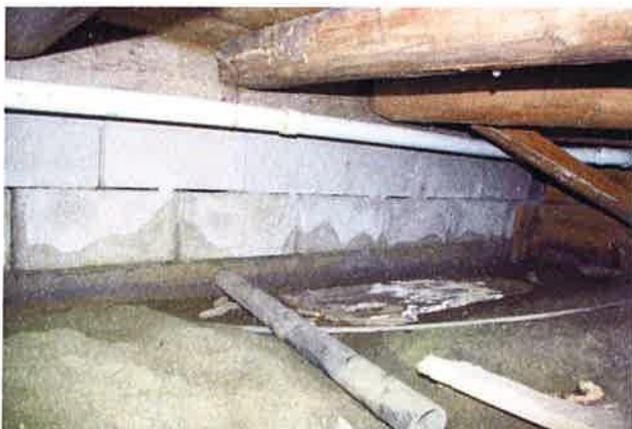
The exterior foundation wall is in fair condition. There are areas where there is noticeable shifting and deterioration of the wall. The interior CMU masonry piers appear to be dry laid (no mortar in the joints) and are in fair condition.

CMU Masonry Foundation Wall

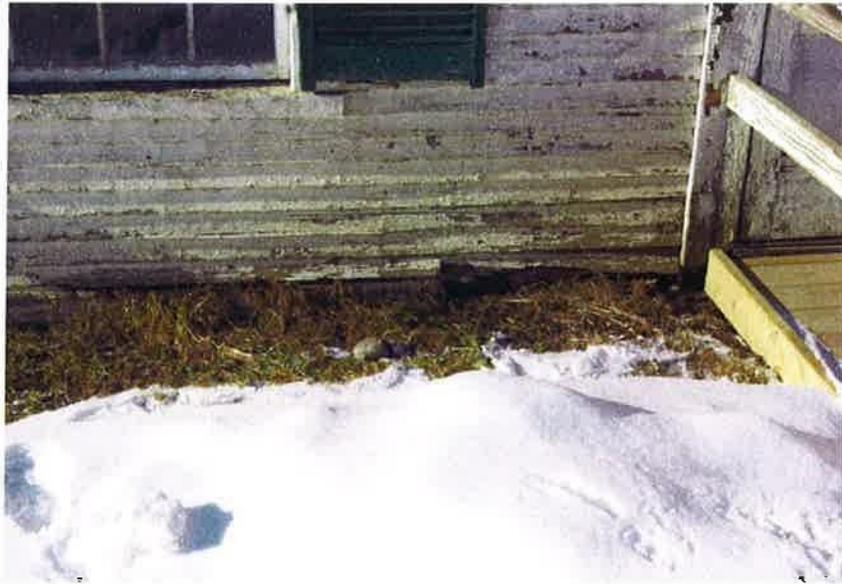
Timber sills were noted to have rotted especially at the north and east sides of the building where they are in contact with the ground.

Buried Sills at Parking Lot Side of Building
