**CALAIS DAM TASK FORCE
FINAL REPORT TO THE SELECTBOARD
FEBRUARY 15, 2005**

**CDTF
TASK FORCE REPORT
February 15, 2005**

REPAIRS TO CURTIS POND DAM
CALAIS, VT

ALTERNATIVES APPRAISAL

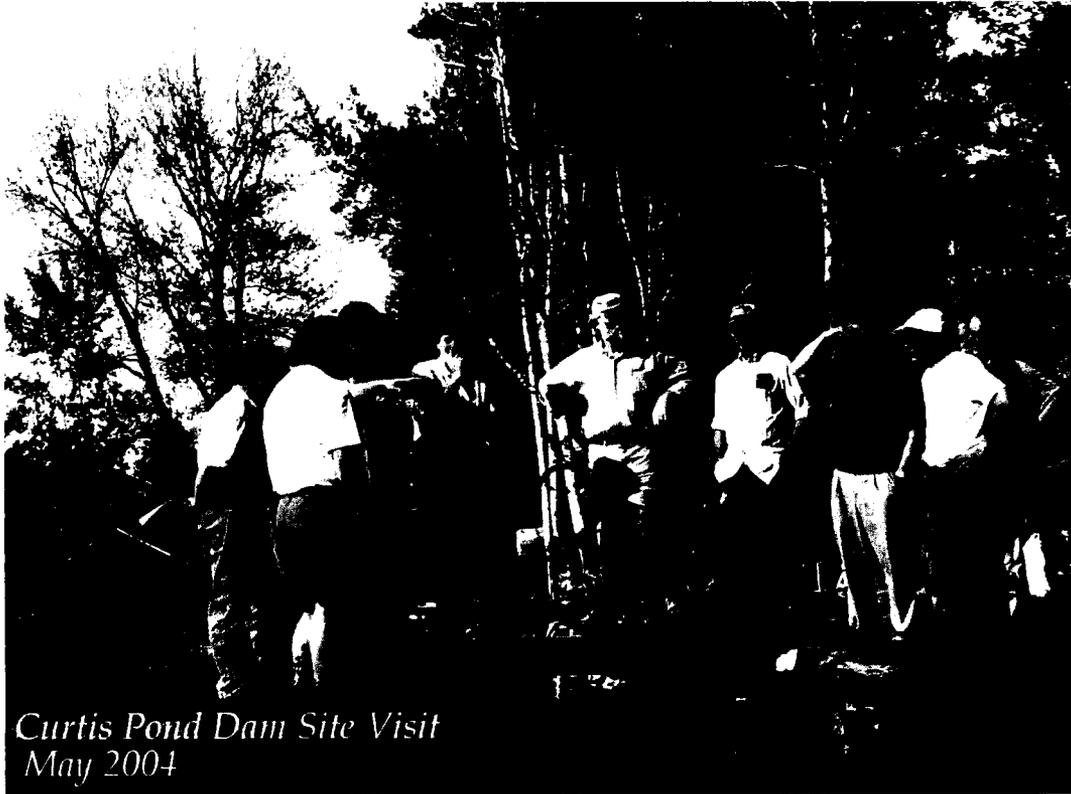
*Curtis Pond Dam Site Visit
May 2004*
