TOWN OF CALAIS

TOWN HIGHWAY No. 53, MARTIN ROAD

INFORMATIONAL REPORT re: the
EXISTING STONE BOX CULVERT
NEAR JUNCTION WITH TH 6, ADAMANT ROAD

PREPARED BY NEWTON TECHNICAL SERVICES
MAY 2014

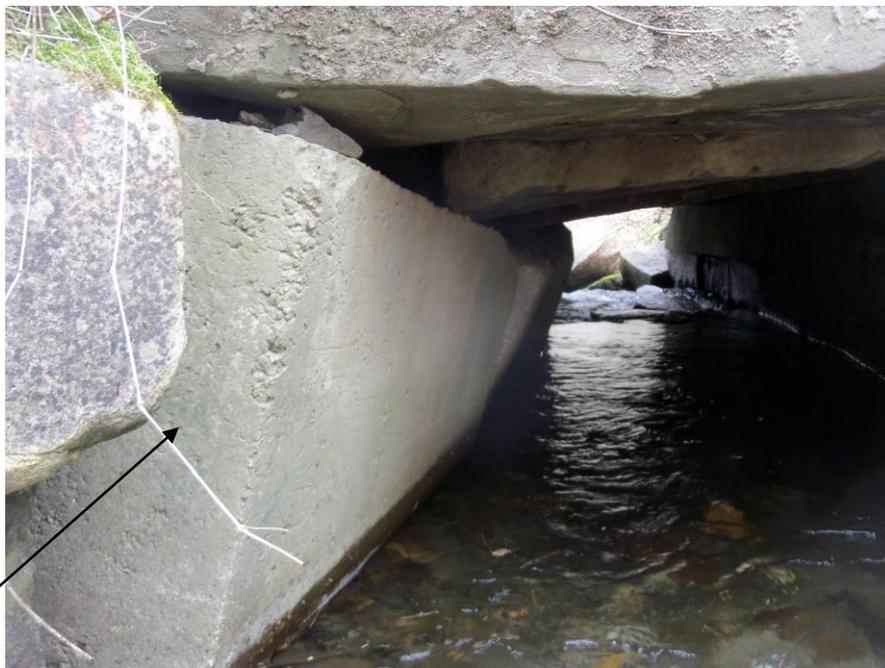
The southerly “wall” (on the side towards Adamant Road) of the box consists of a series of rectangular granite blocks laid on top of each other; the blocks appear to have been laid “dry” meaning that no mortar was used between the blocks. The northerly “wall” is made up of some concrete waste blocks; those blocks are 2' wide x 2' high x 4' long and are laid with the 4' dimension horizontal. Apparently at least 16 years ago, whatever had been used for the original wall on that side of the box had failed to the point that it was removed and these waste blocks were installed. Neither of the walls extends below streambed grade so any degradation of the stream might result in some scour and subsequent undermining of the walls. That appears to be what is happening to the waste blocks on the northerly wall; the blocks have become undermined to the point that the tops of them are starting to rotate in towards the stream and become unstable. The picture below indicates that rotation.

Blocks are rotating inwards due to loss of stability at streambed level

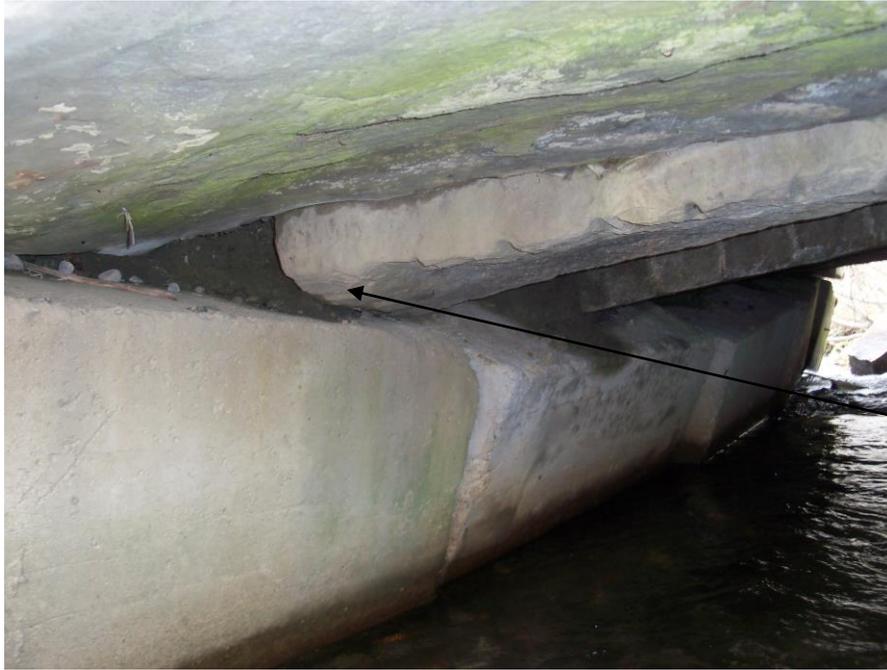
The “roof” of the stone box is made up of some large flat granite slabs that rest on the top of each wall and span across the opening. With the northerly wall starting to rotate inwards, the ends of the roof slabs on that end are not fully supported by the blocks. See the picture below.

Roof slabs are losing some of their bearing due to the rotation of the blocks on the northerly wall

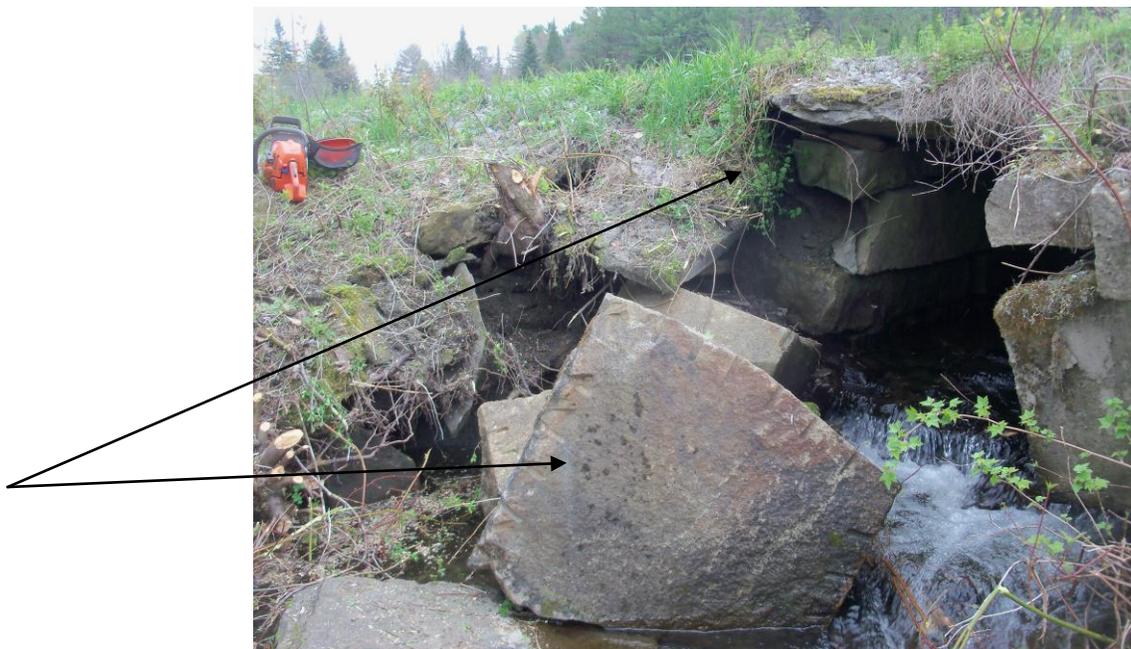
The outlet end of the southerly wall has also started to fail and some of the granite blocks and stones on that end of the box have fallen into the brook and are constricting the flow.

Blocks have fallen out of place and are constricting the flow in the stream
