CALAIS TOWN  
HALL REHABILITATION  
PLAN  
2.6.17

Town of Calais  
Calais, Vermont

**CALAIS TOWN HALL REHABILITATION PLAN**

February 6, 2017

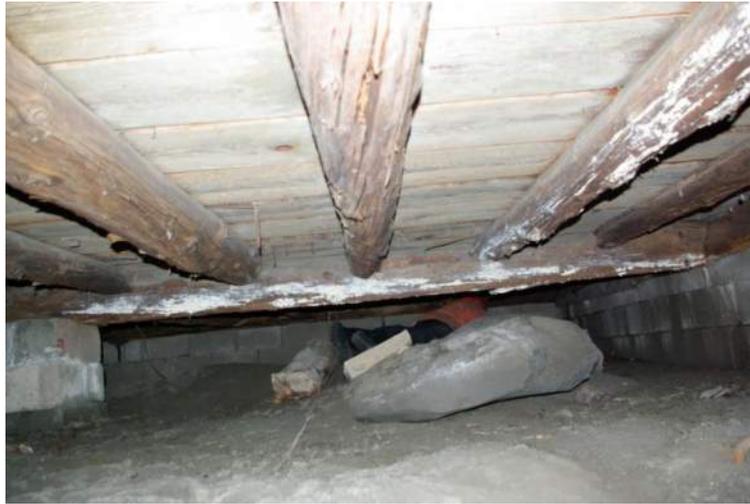
**Crawl Space Below Lower Floor**

The proximity of the very damp soil conditions in the crawl space to the framing has allowed the timbers to have very high moisture content. Framing for the north two bays has rotted substantially to the point that its load carrying capacity is limited and mold is present.
