CALAIS TOWN HALL REPORT

February 25, 2013

Site and Building Assessment and Findings

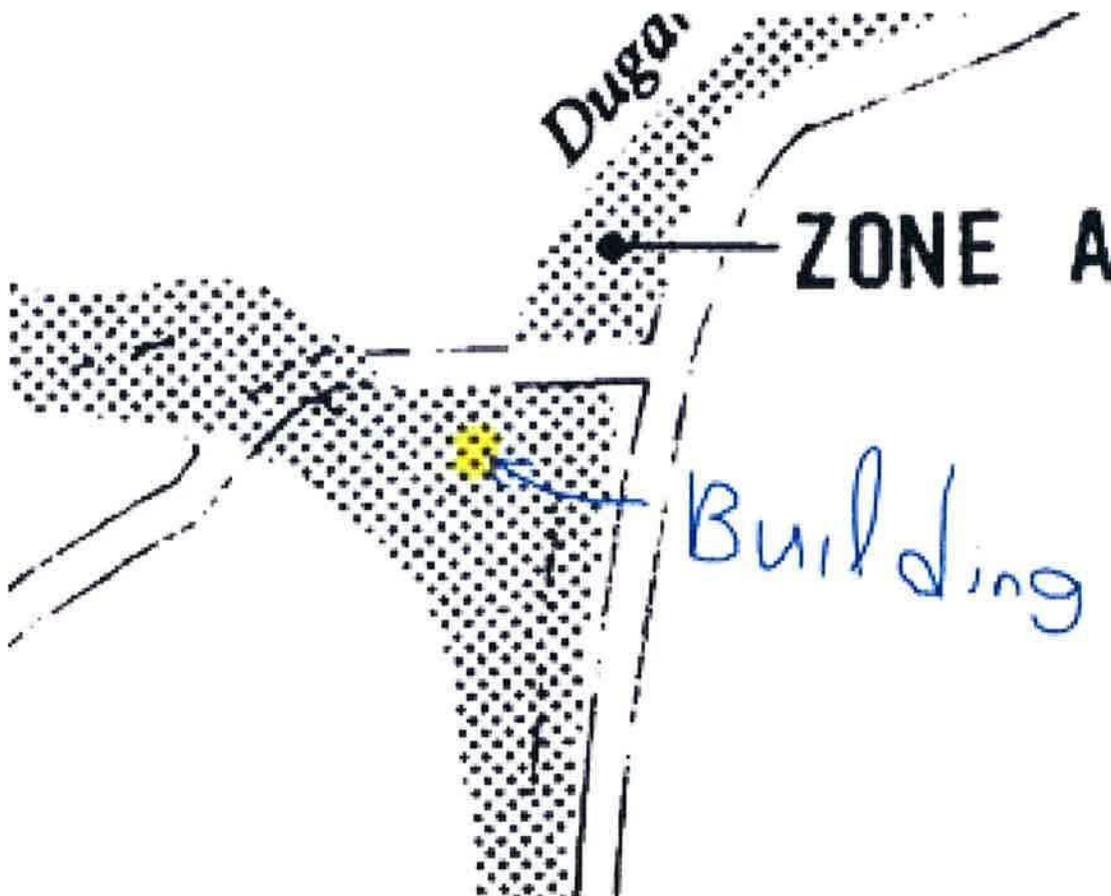
The building experienced a flood in 1984 which is marked on the lower floor at about 28" above the floor level. It is understood that the Building Committee has had discussion regarding flood potential on the lower level and has been reluctant to move forward with any additional renovations without a better understanding regarding flood risk. The 1960's FEMA flood mapping (FIRMETTE) shows the building clearly in the 100 year flood zone. Based on interpolation of this map, the 100 year flood elevation would likely have been considered at somewhere between one and four feet above the lower floor. (See Below)

FEMA FLOOD MAP- 100 YEAR FLOOD ZONE – 1960'S NOW VOID

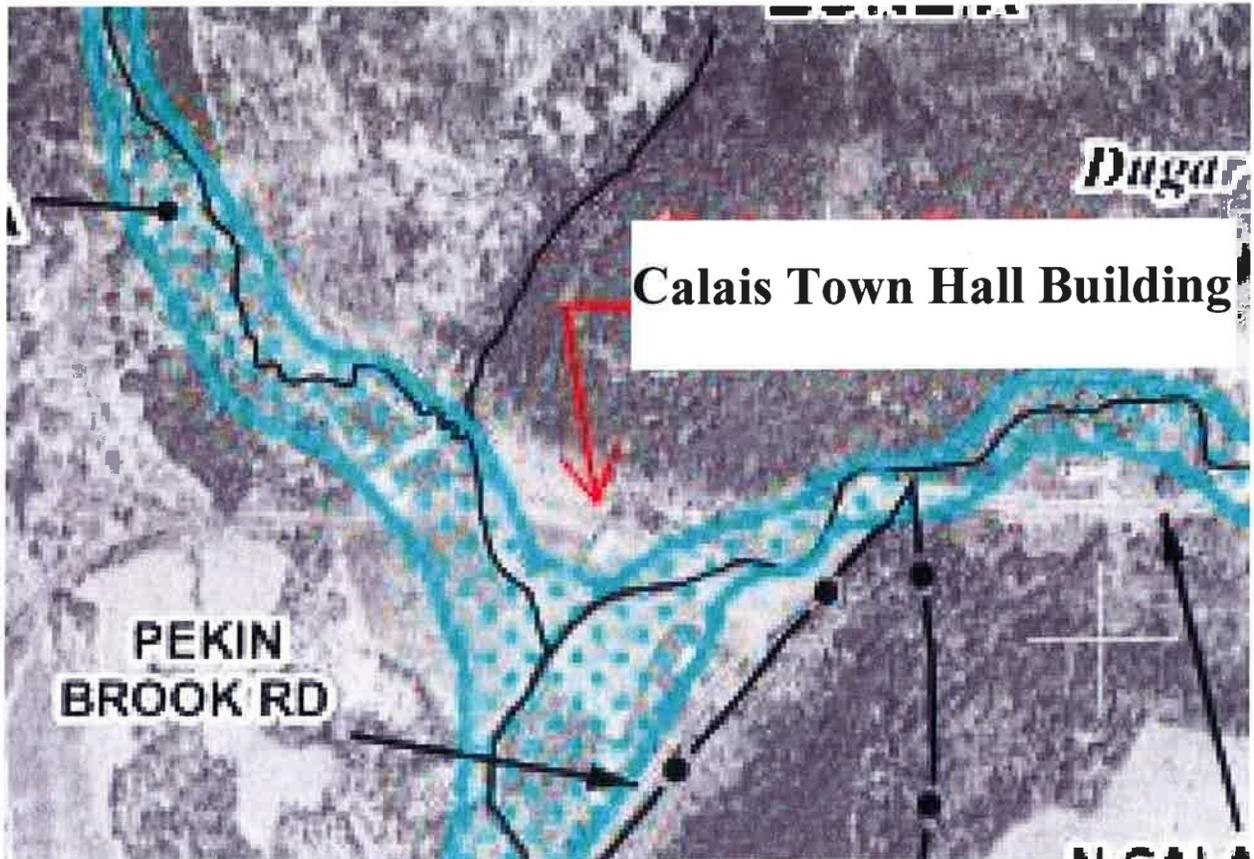
Recent re-mapping has been completed by FEMA (effective March 2013) which clearly shows the building outside of the 100 year flood zone. The line of the Flood Zone is in the field south of the building less than 100 yards away. The topography in this area is gently sloping indicating that the building is only moderately higher than the 100 year flood elevation.

FEMA FLOOD- MAP MARCH 2013 - 100 YEAR FLOOD ZONE

Neither of the FEMA studies (1960's or current) were done in enough detail to allow a specific 100 year flood elevation to be determined. The removal of the building from the 100 year flood zone as mapped by FEMA means that Flood Mitigation Grants from the Federal Government are not possible unless there are three documented flood events. It is understood that this documentation is not available.

- Raise the elevation of the building approximately two to three feet.
- Place a new concrete slab with vapor barrier in the crawl space.
- The new foundation would be designed to resist flood water infiltration into the crawl space. However, due to the structural implications of keeping the floor slab from floating, water

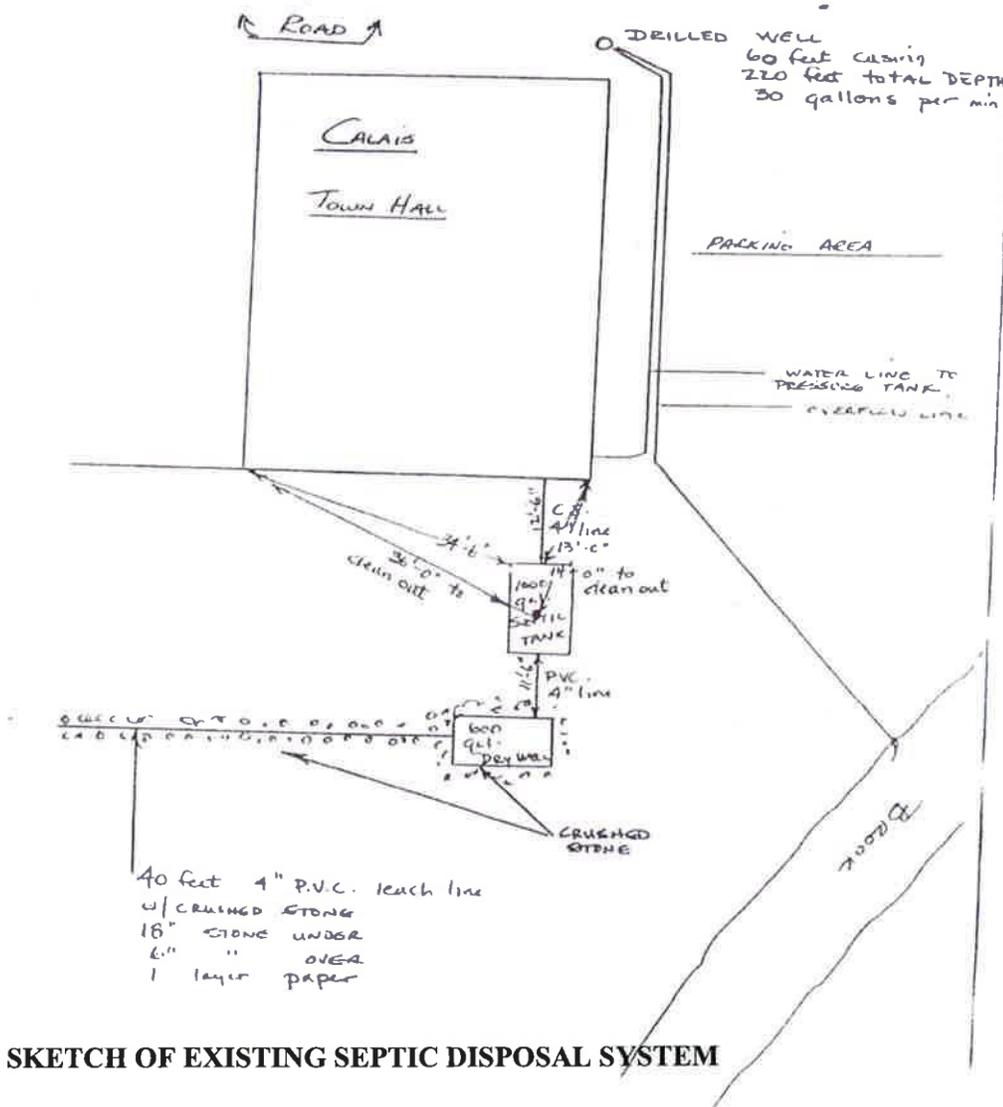
A schematic drawing of the existing septic disposal system was provided by the Building Committee (see below). The system consists of a septic tank and a dry well. This system is allowed as an existing system with intermittent use. If the building is to be considered for full time use or for events, improvements may be required.

SCHEMATIC SKETCH OF EXISTING SEPTIC DISPOSAL SYSTEM

- Provide periodic maintenance and inspection of the system including pumping out the septic tank.
- Monitor periodically and review for potential failure.
- Protect the system from damage during construction activities.

- Plan for further evaluation, replacement or use of portable toilets if more sustained use or a change of use is anticipated.

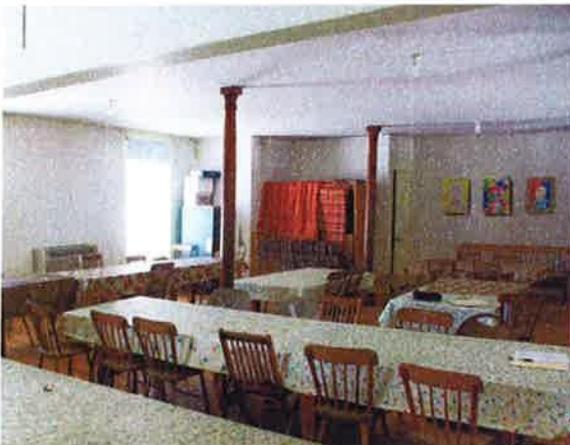
First Floor Posts Supporting Second Floor

A portion of the second floor framing was observable by removing sections of floor boards. The floor joists are 3" x 9" timbers at 24" spacing. The beams were not observed, but appear to be supported on the system of posts observed at the first floor. The required loading for this area is 60 psf for "fixed seating assembly."

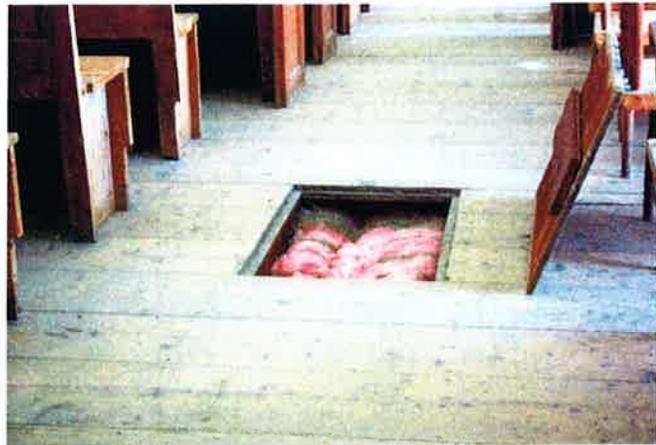
Second Floor Framing Access Hole

- The floor appears to be in good, serviceable condition. Second floor use should not be altered; fixed seating should remain and tightly packed crowds should be avoided in the aisles and open areas.
- The front entry and stair framing should be reinforced or replaced. The framing is very lightly framed and has limited capacity.

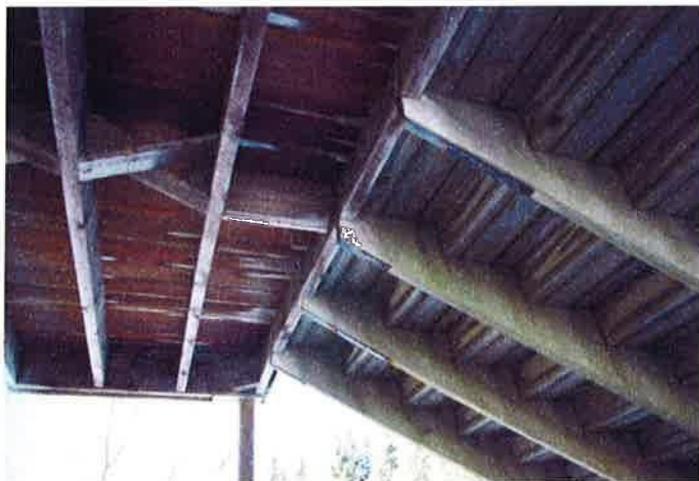
Entry and Stair Framing
