TOWN OF CALAIS

TOWN HIGHWAY No. 53, MARTIN ROAD

INFORMATIONAL REPORT re: the
EXISTING STONE BOX CULVERT
NEAR JUNCTION WITH TH 6, ADAMANT ROAD

PREPARED BY NEWTON TECHNICAL SERVICES
MAY 2014

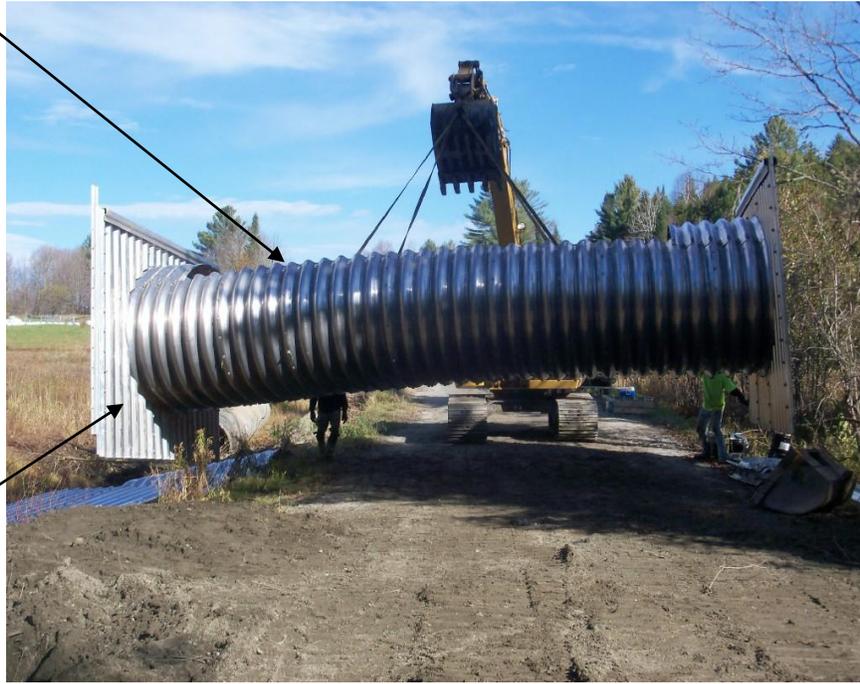
Assembled aluminum pipe arch with headwalls about to be set in place
Portion of the roof section left open to facilitate adding streambed material once in place

One structure that would work is a corrugated aluminum pipe arch that has an 8'-10" span and a 6'-1" rise. It meets the minimum clear span of at least 8' and has an original waterway area of 43 square feet. When it is buried 2' to meet the ANR requirements, it loses some waterway area but still has 33.49 square feet left which is slightly more than the 32 sf that is required. The headwalls and wingwalls are also made from corrugated aluminum plate and have anchor rods and deadmen to provide stability; the anchor rods are attached to both the headwalls and the wingwalls; the ones from the headwalls are attached to the pipe arch and the ones attached to the wingwalls are buried in the slope.

Another feature about this type of structure is that you can leave the majority of the roof section open when you set it in place; that allows the contractor to use an excavator to put the 2' of streambed material into the bottom of it rather than having to do it by hand. Once the material is in place, the rest of the roof panels can be set, bolted into place and then backfill and compaction operations can begin.

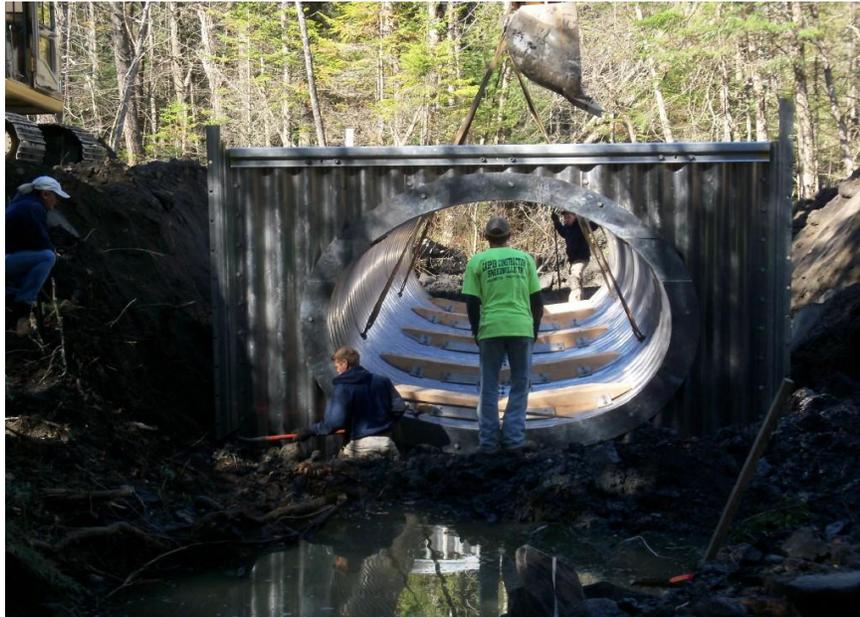
Aluminum pipe arch being set in place; headwalls are already attached
